**Harry Edelman^a, Toni Pakkala^b, Eero Tuominen^c, Arto Köliö^d, Miia Jauni^e,
Matti Pentti^f, Mihkel Kiviste^g, Juha Vinha^h, Susanna Lehvävirtaⁱ**

Moisture Safety of Green Facades

Abstract

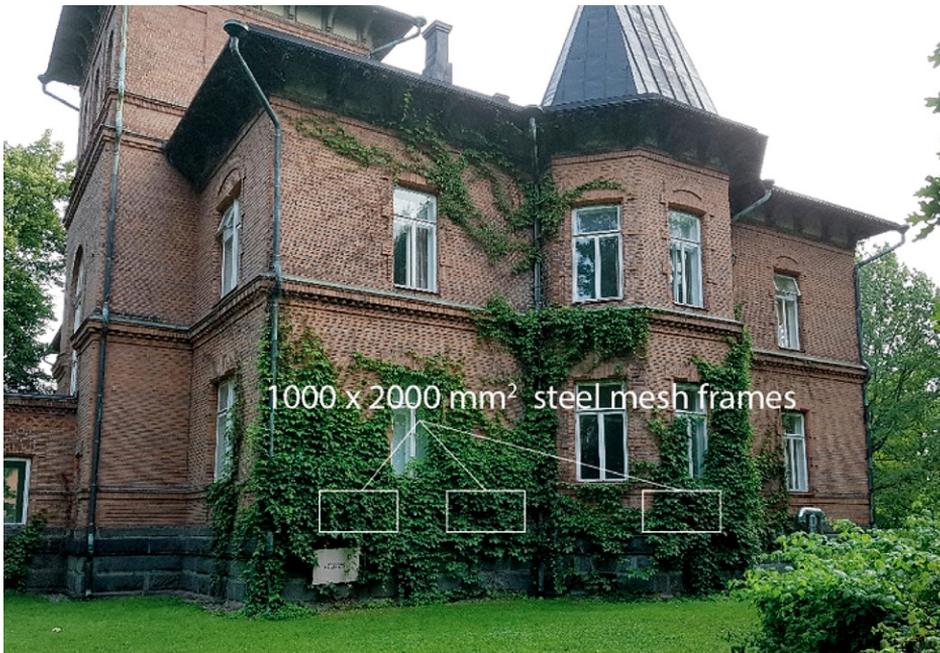
Figure 1. Locations of the mesh frames (1,000 x 2,000 mm²) on the brick wall of the Hiedanranta Mansion for collecting the thickest creeper for the laboratory experiment.

The first study part involved growing and harvesting the thicket creeper to provide material for the study. The creeper grew on the brick wall of the old Hiedanranta Mansion (Fig. 1). Three 1000 x 2000 mm² steel reinforcement meshes, each with a grid of 150 x 150 mm² were installed behind the thicket creeper on 2017-05-24 allowing the plant to grow and attach to each mesh for 100 days until harvested on 2017-09-01. The diameter of the branches of the creeper varied between 2-25 mm. After the growing period, the leaves covered the mesh 100% without any visual access through the mesh, thus fully covering the facade.

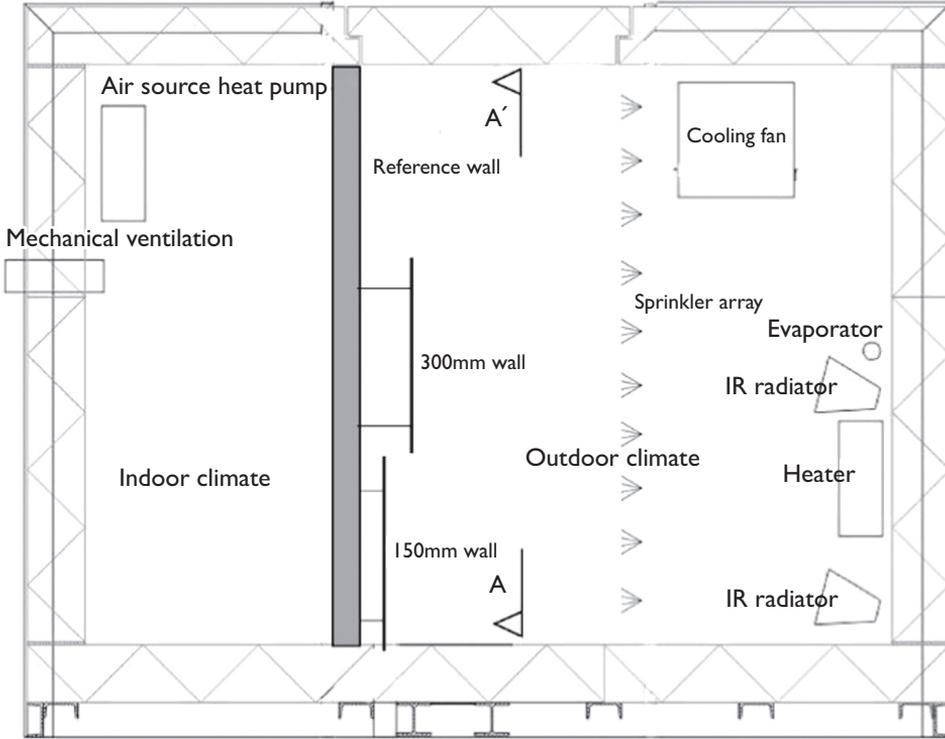
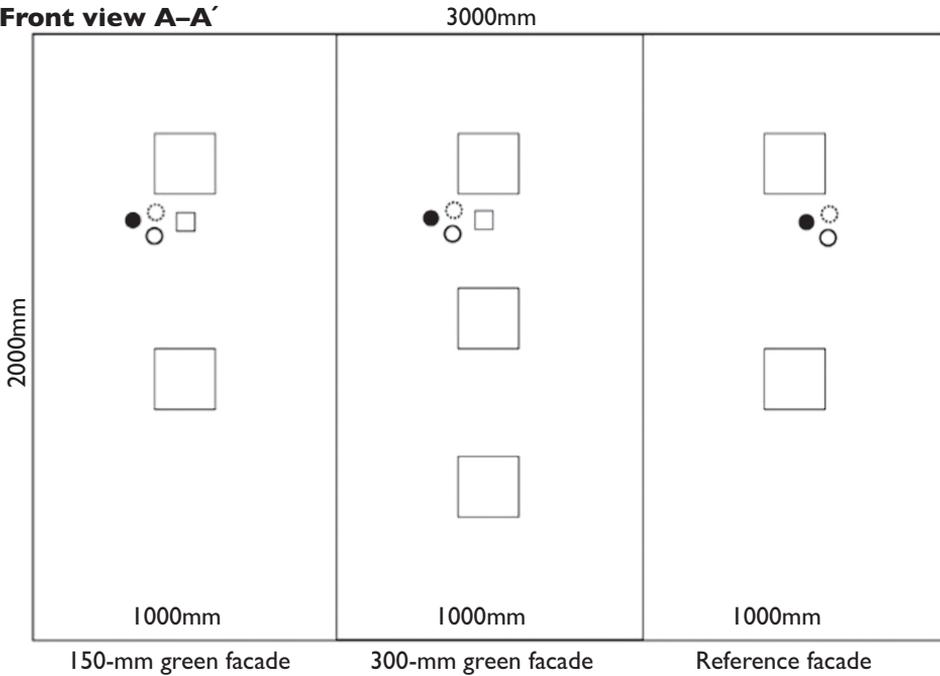
Floor plan

Front view A-A'

Figure 2 a and b. a Floor plan of accelerated weathering laboratory equipment (AWLE) and b front view of the mock-up facade with the locations of the sensors: front i.e. sensor located inside the concrete wall, 30 mm below the facade surface; surface i.e. sensor located at the surface of the wall; rear i.e. sensor located in the centre of the concrete wall, 50 mm below the surface); and creeper sensors i.e. sensors located on the surface of the thicket creeper on 150- and 300-mm green facades.

Description of AWLE conditions and equipment. The mock-up wall placed inside the AWLE was equipped with four Rotronic Hygrolog HL-NT3 dataloggers, each equipped with three hygroclip 2 A sensors for measuring temperature and humidity. The RH sequence behaved logically throughout the experiment indicating a solid performance of the hardware. The research configuration of the wall is described in Fig. 2 indicating the positions of the sensors, the locations of the 150- and 300-mm green facades each 1,000 x 2,000 mm², and the bare reference concrete wall 1,000 x 2,000 mm². Sensors were placed inside the concrete drilled 50 mm from the back surface (mid wall), inside the concrete drilled 30 mm from the front side, on the surface of the concrete, and under the canopy attached to a mesh, 150 mm or 300 mm away from the concrete, depending on the void of the double skin facade. The sensors at the surface and canopy were equipped with protective caps preventing them from direct rain events. Seven wind-driven rain water collectors with an opening of 200 x 200 mm² and a tank for water collection were mounted on the concrete wall, measuring the amount of water hitting the wall surface (l/m²/h).

The order of the panels was fixed (see Fig. 2.) with an assumption of no impact on the experiment since, in the laboratory conditions, the wind impact was perpendicular to the wall, thus representing a stable weather condition. The variation of the conditions was not feasible as it would have required changing the background concrete wall for each experiment for testing variable weather conditions such as the impact of wind direction. Furthermore, the RH levels and structure of each concrete wall should have been the same at the beginning of the experiment for comparable results, which would have required a

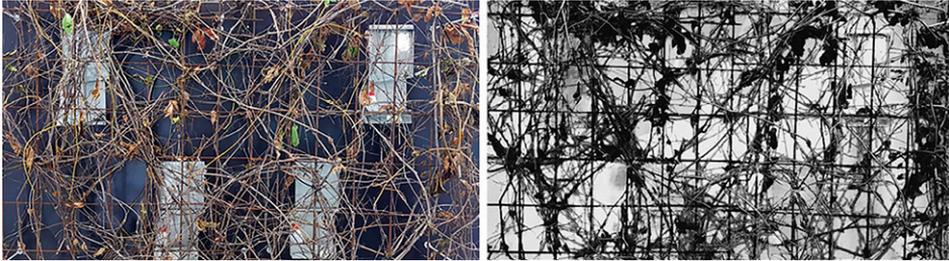
Figure 3 a and b. Image processing for the leafless thicket creeper density. Left panel (3 a) shows RGB image of the mock-up wall. The right panel (3 b) shows the same image in black-and-white with high contrast showing the hard wall surface clearly for enabling the pixel count.

Density analysis of the leafless creeper. The density of the creeper covering the wall must be known in order to analyse its protective qualities impacting the moisture performance of the double-skin wall. The density of the leafless thicket creeper together with the mesh was measured with the pixel ratios of the protective components (creeper and double-skin structures) and the background surface, that is, the area of the wall. A projection image was taken of the wall structure. The veneer surface of the background wall was separated from the mesh and the thicket creeper through image processing (Fig. 3.), then the number of pixels covering the creeper and the mesh were counted and compared to the total number of pixels using Adobe Photoshop software. The total area of the mock-up wall image was 6,684,804 px (3,444 x 1,941 px). The area covered by the leafless creeper with the mesh was 2,899,097 px, so 43% of the total surface offered the functionalities for testing our hypothesis. The information on density was first used to analyse the impact of the creeper autumn (100% cover), winter (43%) and spring (100%) conditions on moisture protection in the AWLE experiment.
